**Loss of Pitch Control During Takeoff
Air Midwest Flight 5481
Raytheon (Beechcraft) 1900D, N233YV
Charlotte, North Carolina
January 8, 2003**

Aircraft Accident Report
NTSB/AAR-04/01

Loss of Pitch Control During Takeoff

Air Midwest Flight 5481

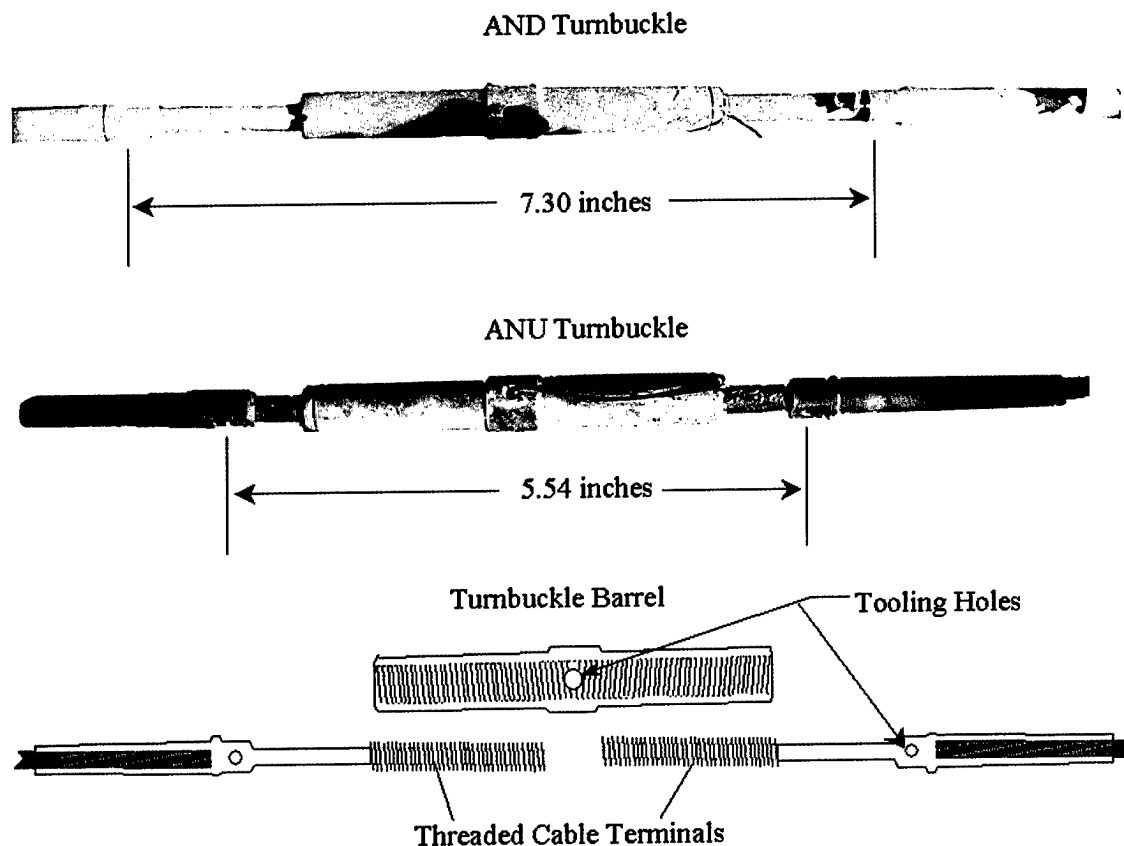
Figure 6. Turnbuckles as found in the wreckage.

The ANU turnbuckle was almost fully contracted, and the AND turnbuckle was almost fully extended. The measurement from the center of the tooling hole in one threaded cable terminal to the center of the tooling hole in the other cable terminal was 5.54 inches for the ANU turnbuckle and 7.30 inches for the AND turnbuckle. In addition, the AND turnbuckle had one thread visible, and the ANU turnbuckle did not have any threads visible. Figure 6 shows the turnbuckles as found in the wreckage and a drawing that shows a turnbuckle barrel and threaded cable terminals.

The AND turnbuckle was extended 1.76 inches more than the ANU turnbuckle. After the accident, Air Midwest surveyed its entire fleet of 42 Beech 1900D airplanes, which represented 25 percent of the 164 Beech 1900D airplanes active in the North American fleet. Air Midwest data submitted to the Safety Board indicated that, on average, the AND turnbuckle was extended 0.04 inch less than the ANU turnbuckle.

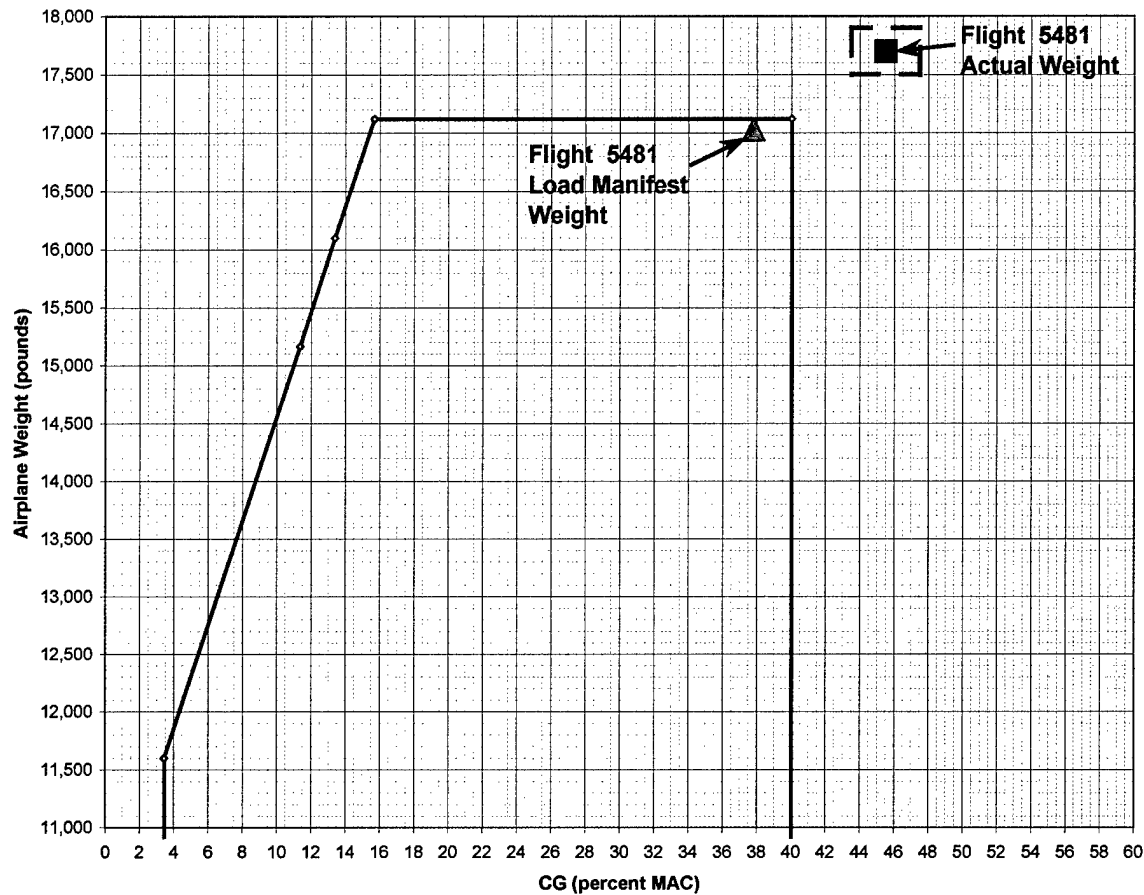
Figure 7. Weight and center of gravity information for flight 5481.

On the basis of these FDR data, radar data, the validated force and moment model, and component weight and location information, the Safety Board determined that the accident airplane had an actual weight of $17,700 \pm 200$ pounds and an actual CG position of 45.5 ± 2 percent MAC. Figure 7 shows the results of the Board's calculations overlaid on the Beech 1900D weight and CG envelope.

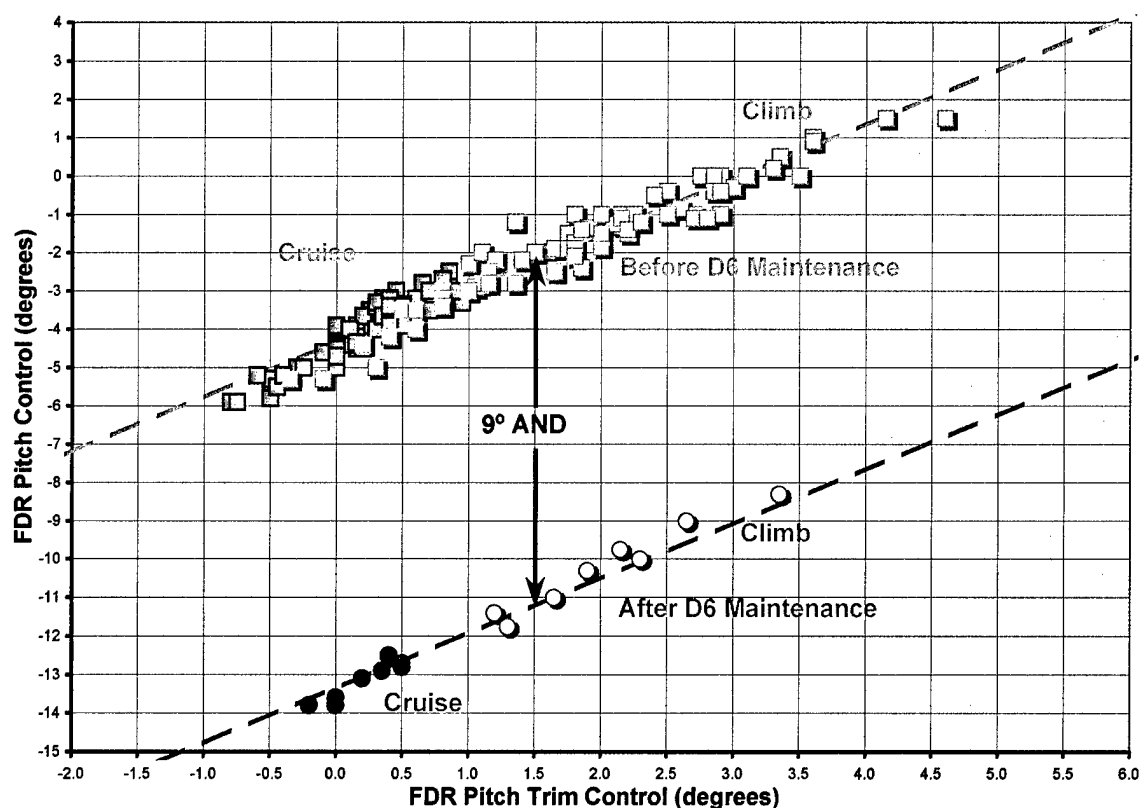
Figure 8. Flight data recorder pitch control and pitch trim control positions.

The position of the trim tab is the predominant predictor of elevator position during climb and cruise flight. Figure 8 shows that a strong correlation exists between elevator (FDR pitch control position) and trim tab (FDR pitch trim control) data. The figure shows two distinct data groups: the larger group represents flights before the D6 maintenance check, and the smaller group represents flights after the D6 maintenance check.

The larger group of data shown in figure 8 (that is, the flights before D6 maintenance) compared well with the Beech 1900D flight test certification data, indicating that the premaintenance FDR pitch control position data represented the actual elevator position to within about 1°. However, the smaller group of data (that is, the flights

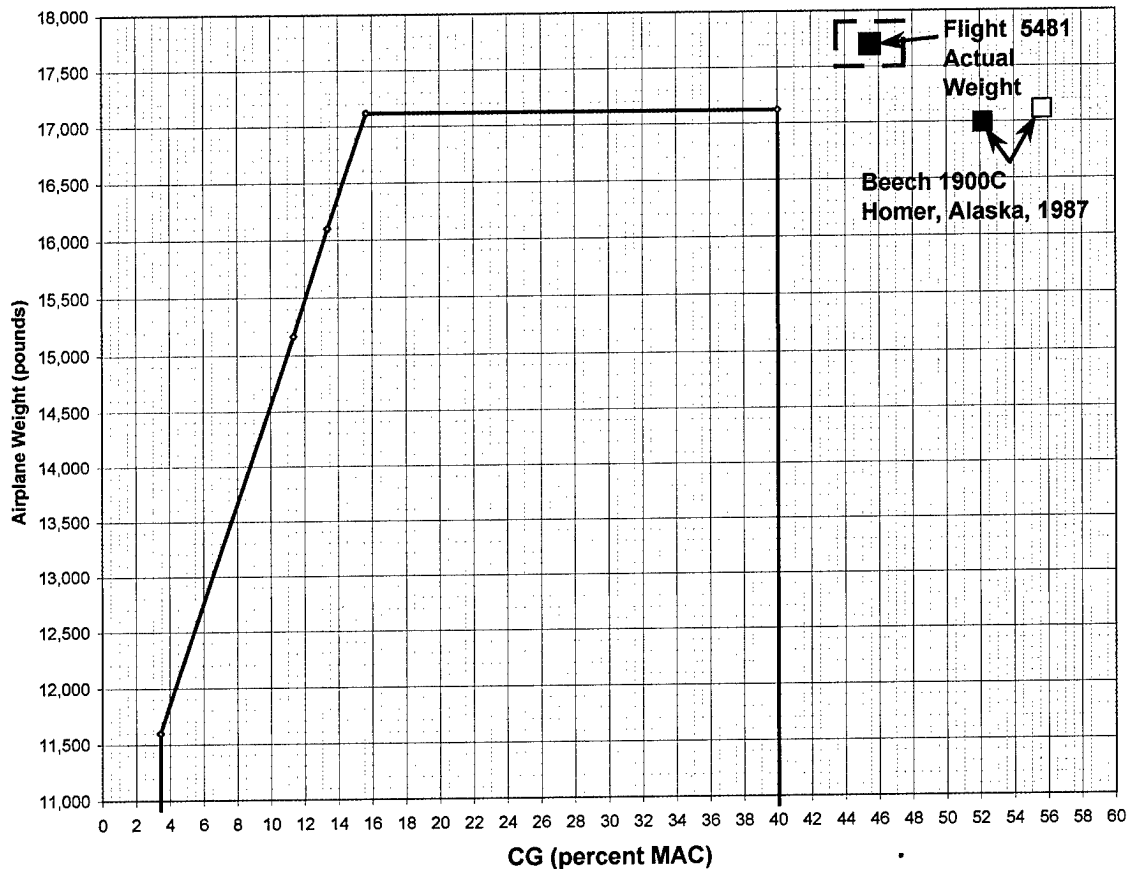
Figure 11. Flight 5481 weight and center of gravity information compared with flight 103 weight and center of gravity information.

Figure 11 shows flight 5481's weight and CG information compared with that for the flight 103 accident airplane. Two data points in the figure show the CG range for the flight 103 airplane.
